### Albury Waste Management Centre Leachate Treatment System

October 2022

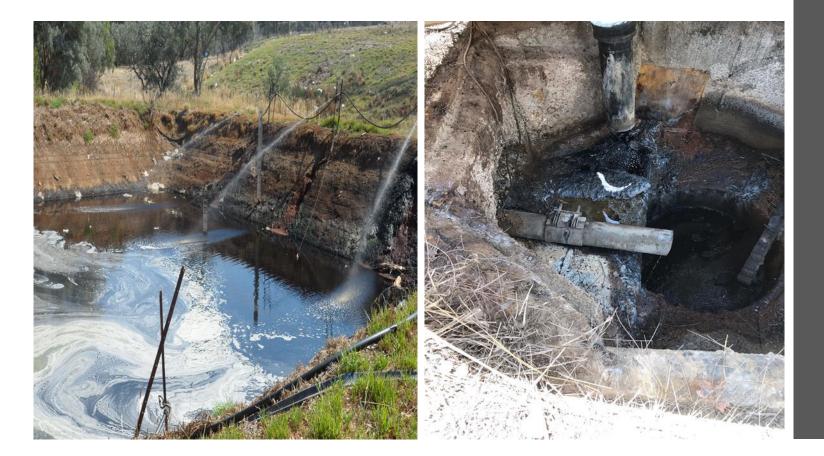
### Original Leachate Management

- Gravity fed Leachate capture system - installed in 1980
- Two clay lined dams
- Liquid piped/aggregate drain to storage dams from putrescible area
- Liquid aerated during storage using homemade spray system
- Managed by evaporation

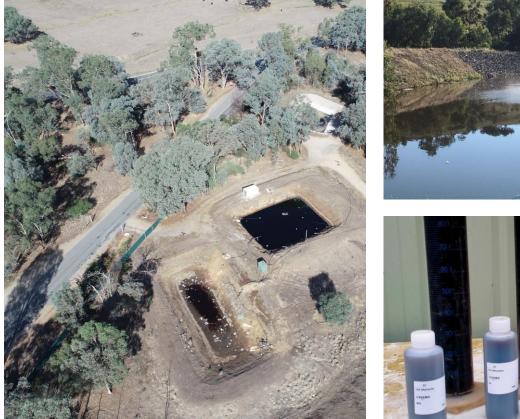
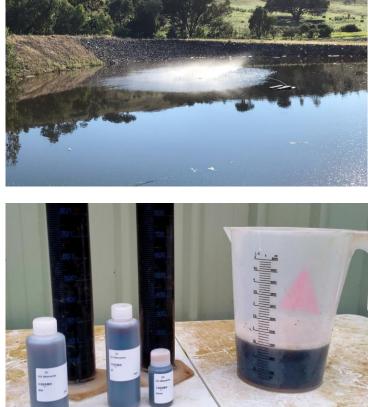
### Problems

- Clear that leachate ponds would not manage the future requirements
- Needed to upgrade or find better solution to manage the leachate generated
- Determine if liquid was suitable to be sent to sewer
- Needed to upgrade the existing ponds
- More storage space
- Holding leachate back in cells due to lack of available storage

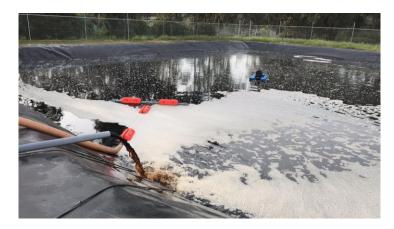
### **Treatment Process**

- Leachate transfers from cell to pump well
- Pumping cuts off 12,500 litres
- Leachate transfers to SBR
- System mixes SBR contents
- SBR contents Aerates for 4.5hrs
- PH levels are monitored and adjusted using caustic soda as needed
- SBR contents settle
- Treated liquid decants to HDPE lined dams
- Treated liquid samples tested at NATA accredited laboratory
- Results must comply with trade Waste requirements
- Treated leachate released to sewer system
